UNITED STATES DISTRICT COURT WESTERN DISTRICT OF TEXAS AUSTIN DIVISION

§	
§	CIVIL ACTION NO. 1:16-CV-365
§	
§	
§	
§	
§	
§	
§

COMPLAINT

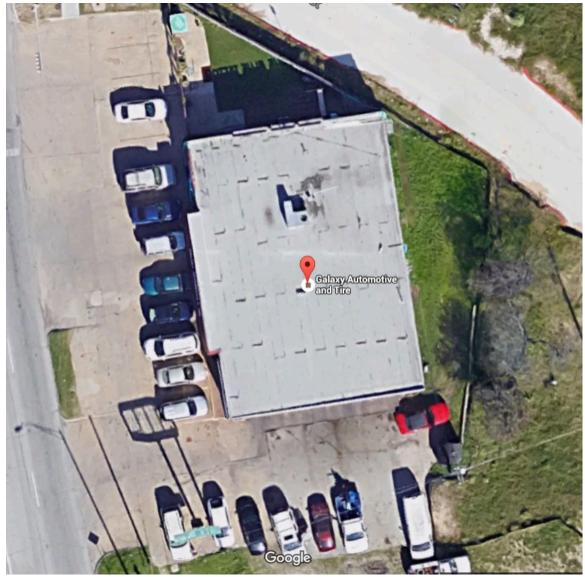
Fig. 1 - Overhead view of GALAXY AUTOMOTIVE & TIRE IN 2015.

Satellite Images from *Texas General Land Office, Texas Orthoimagery Program, U.S. Geological Survey, 2015.* Note: This property has zero ADA-Compliant Disabled Parking Spaces near the business entrance. Under the Americans with Disabilities Act, this business must have 1 ADA-Compliant Van Accessible Parking space (96" Wide with 96" Side Access Aisle) near the business entrance.

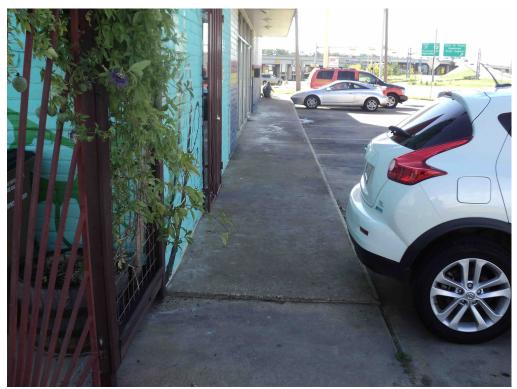
Fig. 6 – Side View of Storefront. Not ADA-Compliant. No Disabled Parking.

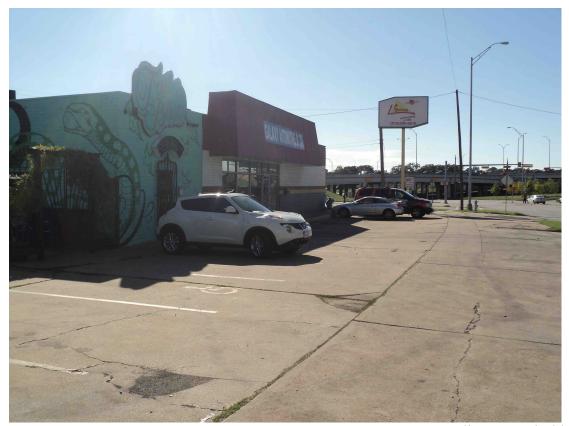
Fig. 8 – View from Northwest Corner of Property. Not ADA-Compliant. No Disabled Parking.

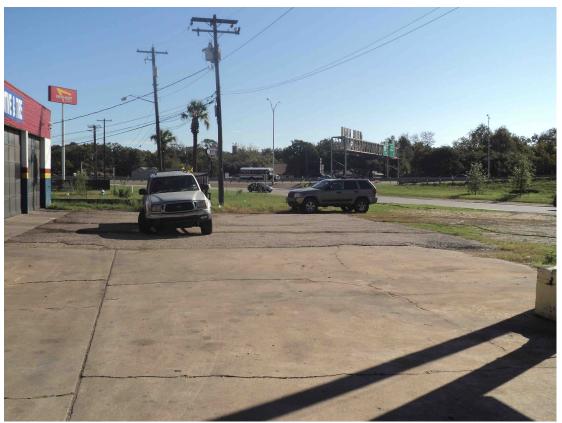
Fig. 10 – South Section of Property. Not ADA-Compliant. No Disabled Parking.
